**AFFDL-TR-78-175**  
**Volume III**

**EFFECT OF MULTIAXIAL LOADING  
ON CRACK GROWTH  
Volume III - Compilation of Interferometry Photographs**

*NORTHROP CORPORATION  
AIRCRAFT GROUP  
HAWTHORNE, CALIFORNIA 90250*

*December 1978*

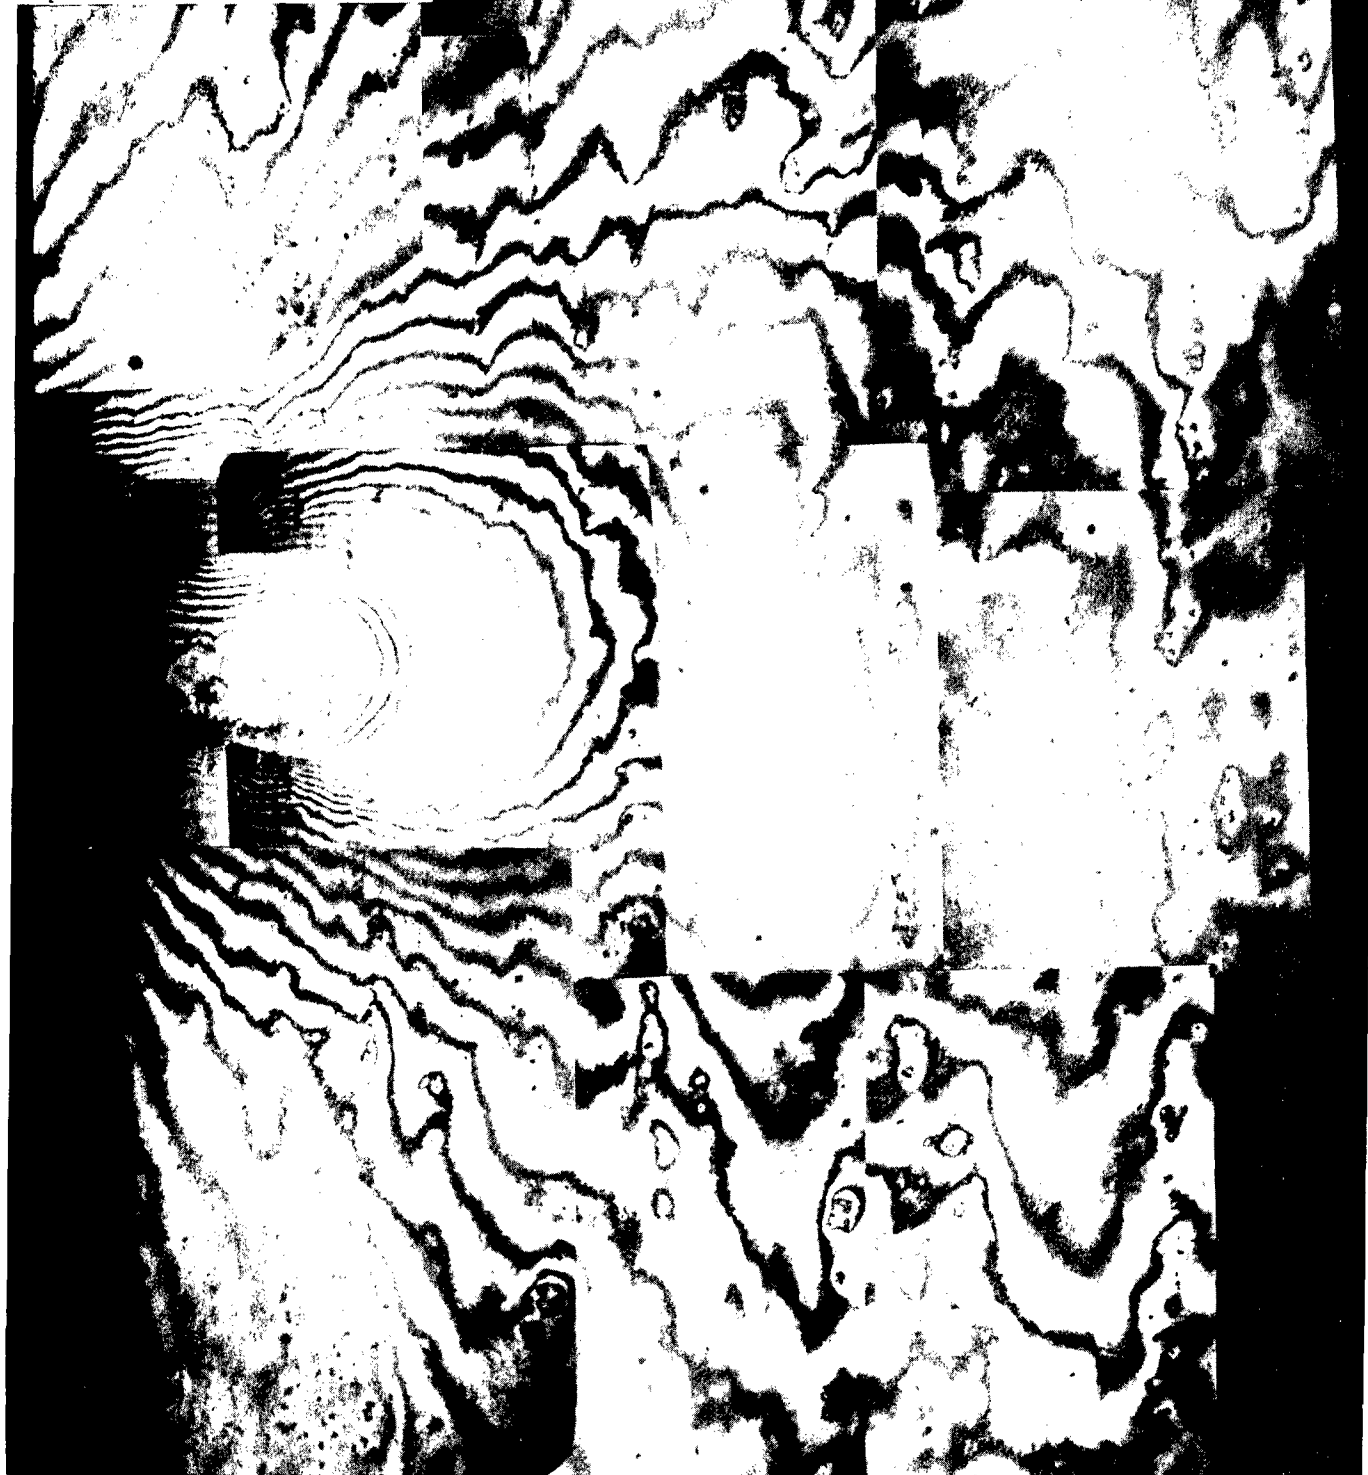
Figure 59. Interferometry Photograph of an Unloaded Crack in a 2024-T351 Specimen

2024-T351,  $a = 0.745$  inch  
 $\sigma_x = 0, \sigma_y = 10$  ksi unloaded  
Magnification: 45.0X  
Test Case 10  
Specimen 2-6-6

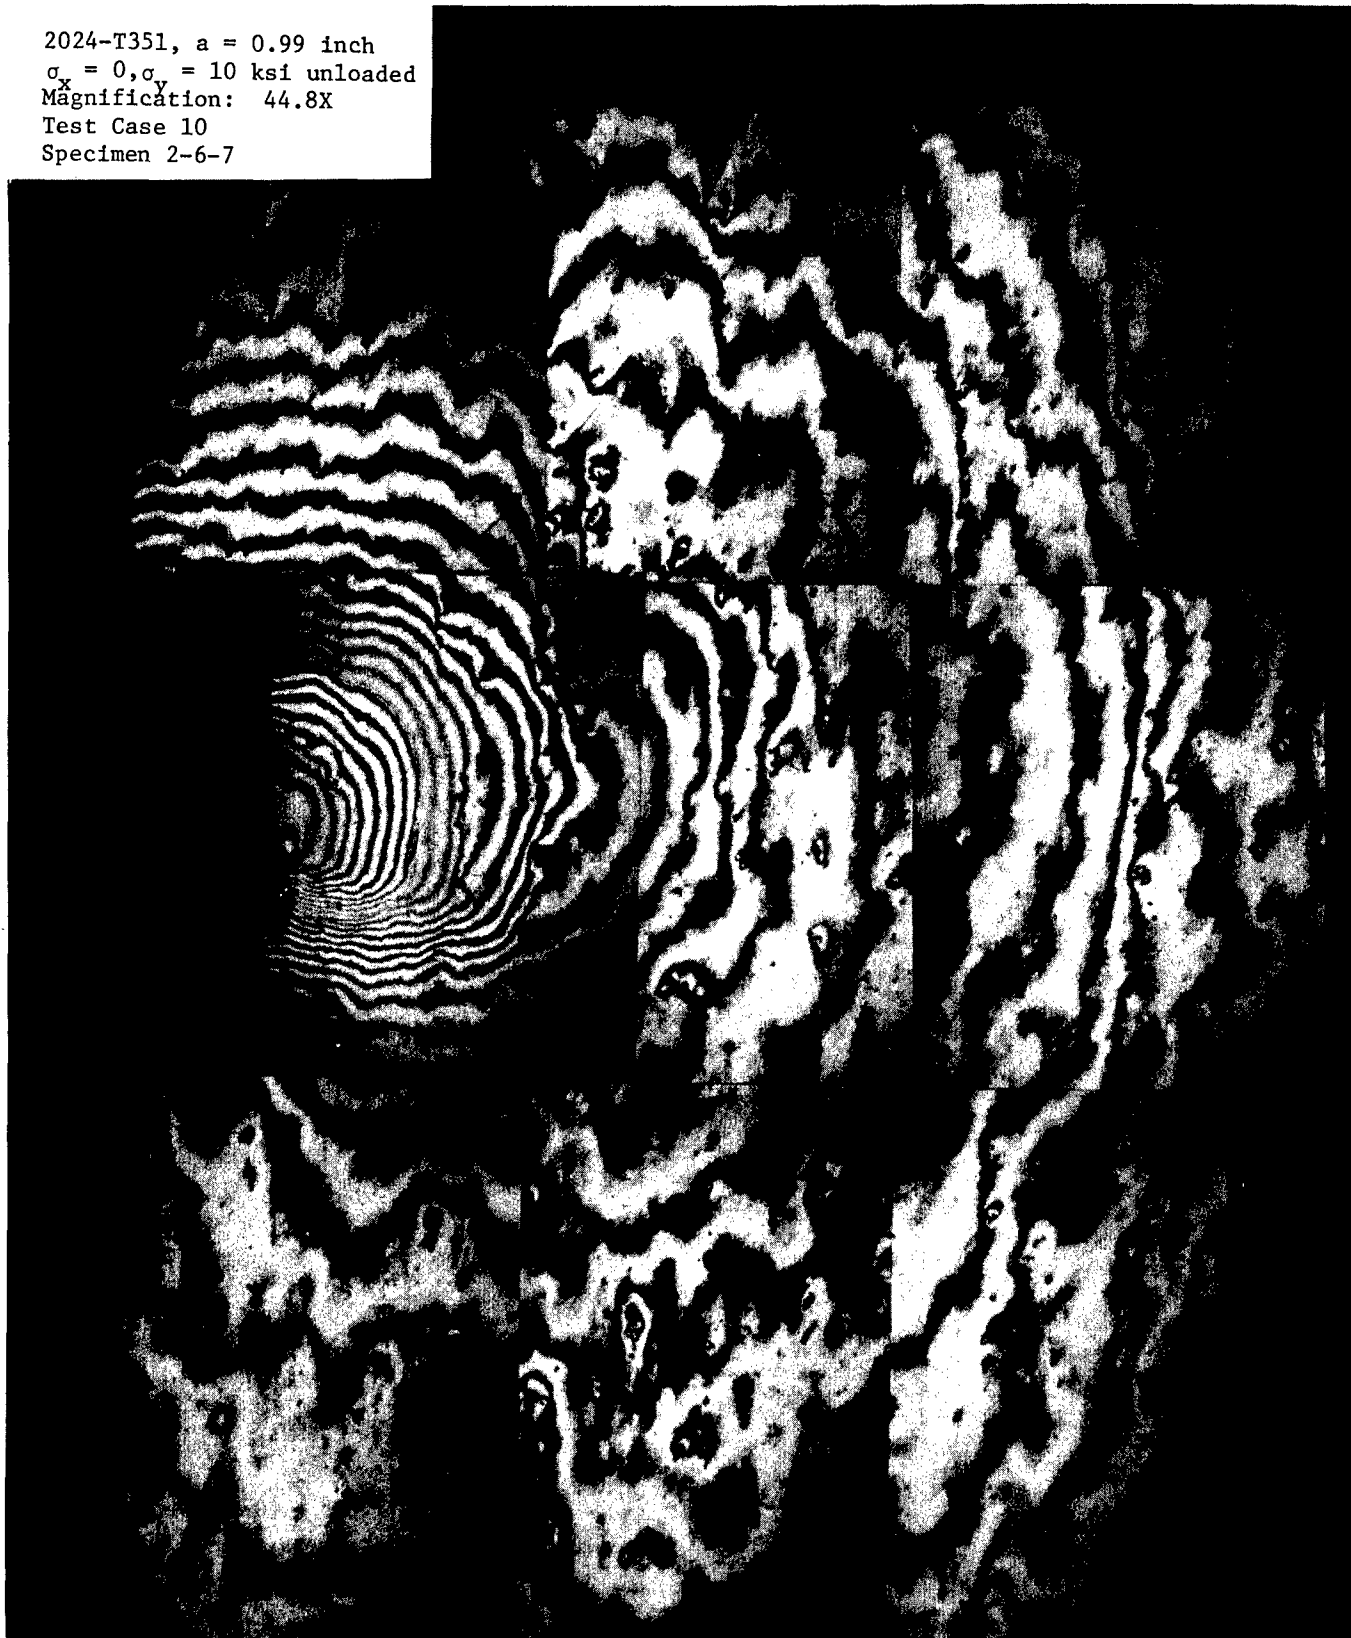
Figure 60. Interferometry Photograph of an Unloaded Crack in a 2024-T351 Specimen

2024-T351,  $a = 0.99$  inch  
 $\sigma_x = 0, \sigma_y = 10$  ksi unloaded  
Magnification: 44.8X  
Test Case 10  
Specimen 2-6-7

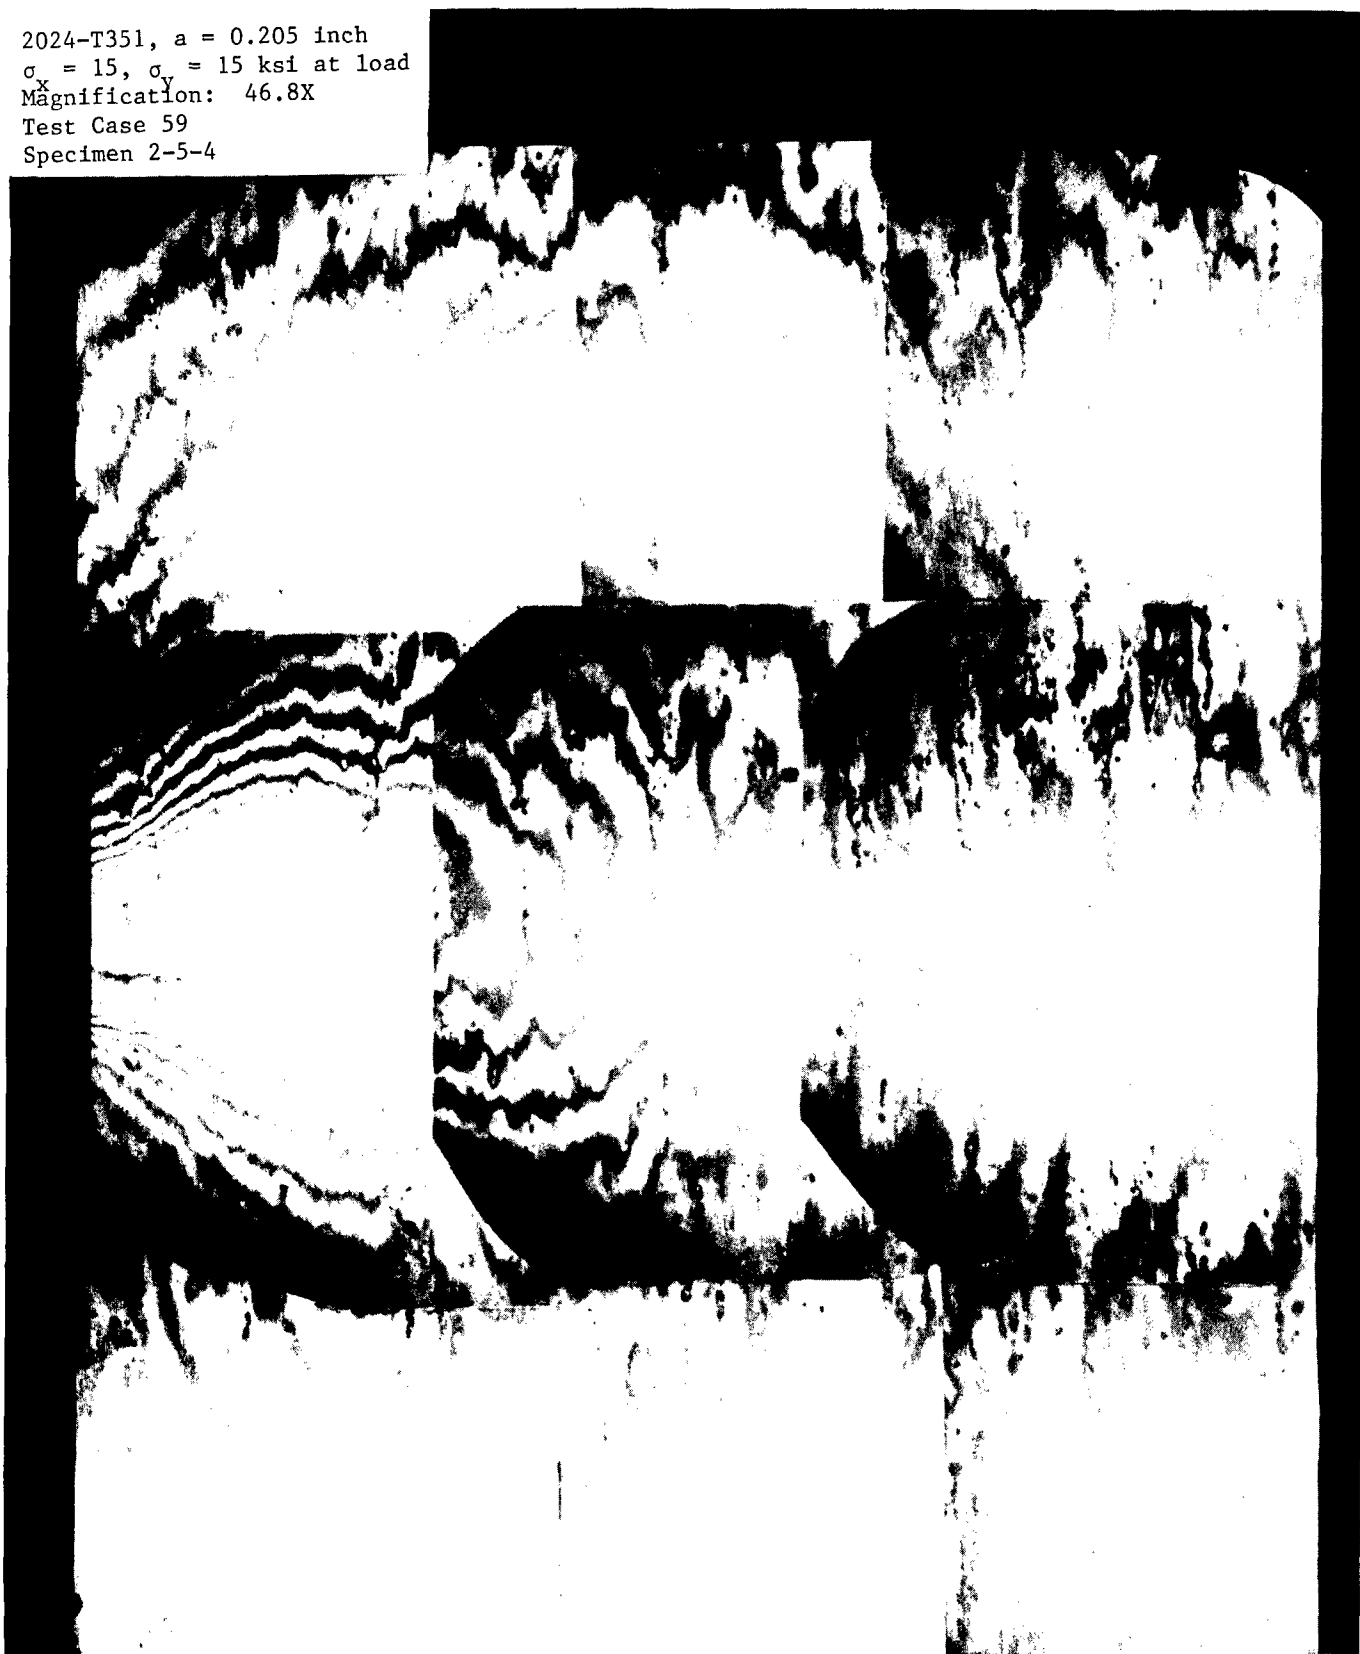
Figure 65. Interferometry Photograph of a Loaded Crack in a 2024-T351 Specimen

2024-T351,  $a = 0.205$  inch  
 $\sigma_x = 15$ ,  $\sigma_y = 15$  ksi at load  
Magnification: 46.8X  
Test Case 59  
Specimen 2-5-4

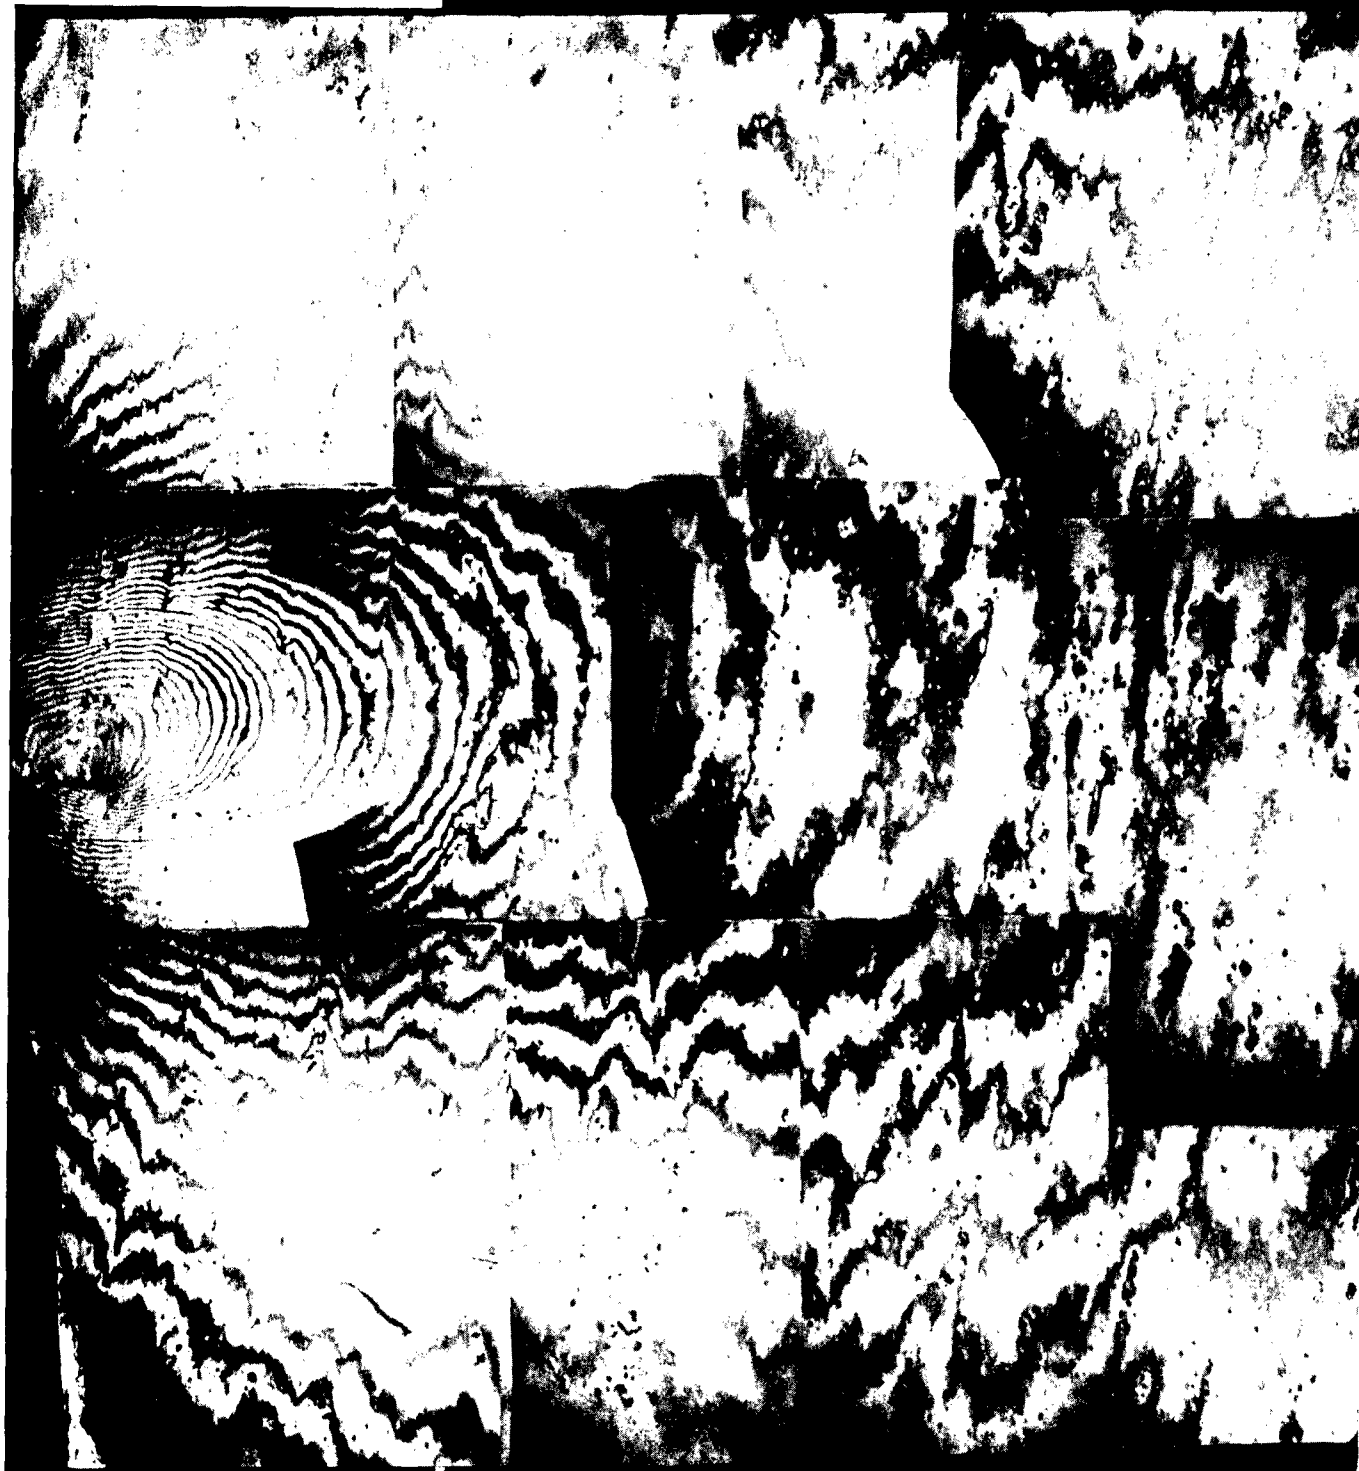
Figure 79. Interferometry Photograph of a Loaded Crack in a 2024-T351 Specimen

2024-T351,  $a = 0.98$  inch  
 $\sigma_x = 10$ ,  $\sigma_y = 10$  ksi at load  
Magnification: 42.4X  
Test Case 31  
Specimen 2-43-6

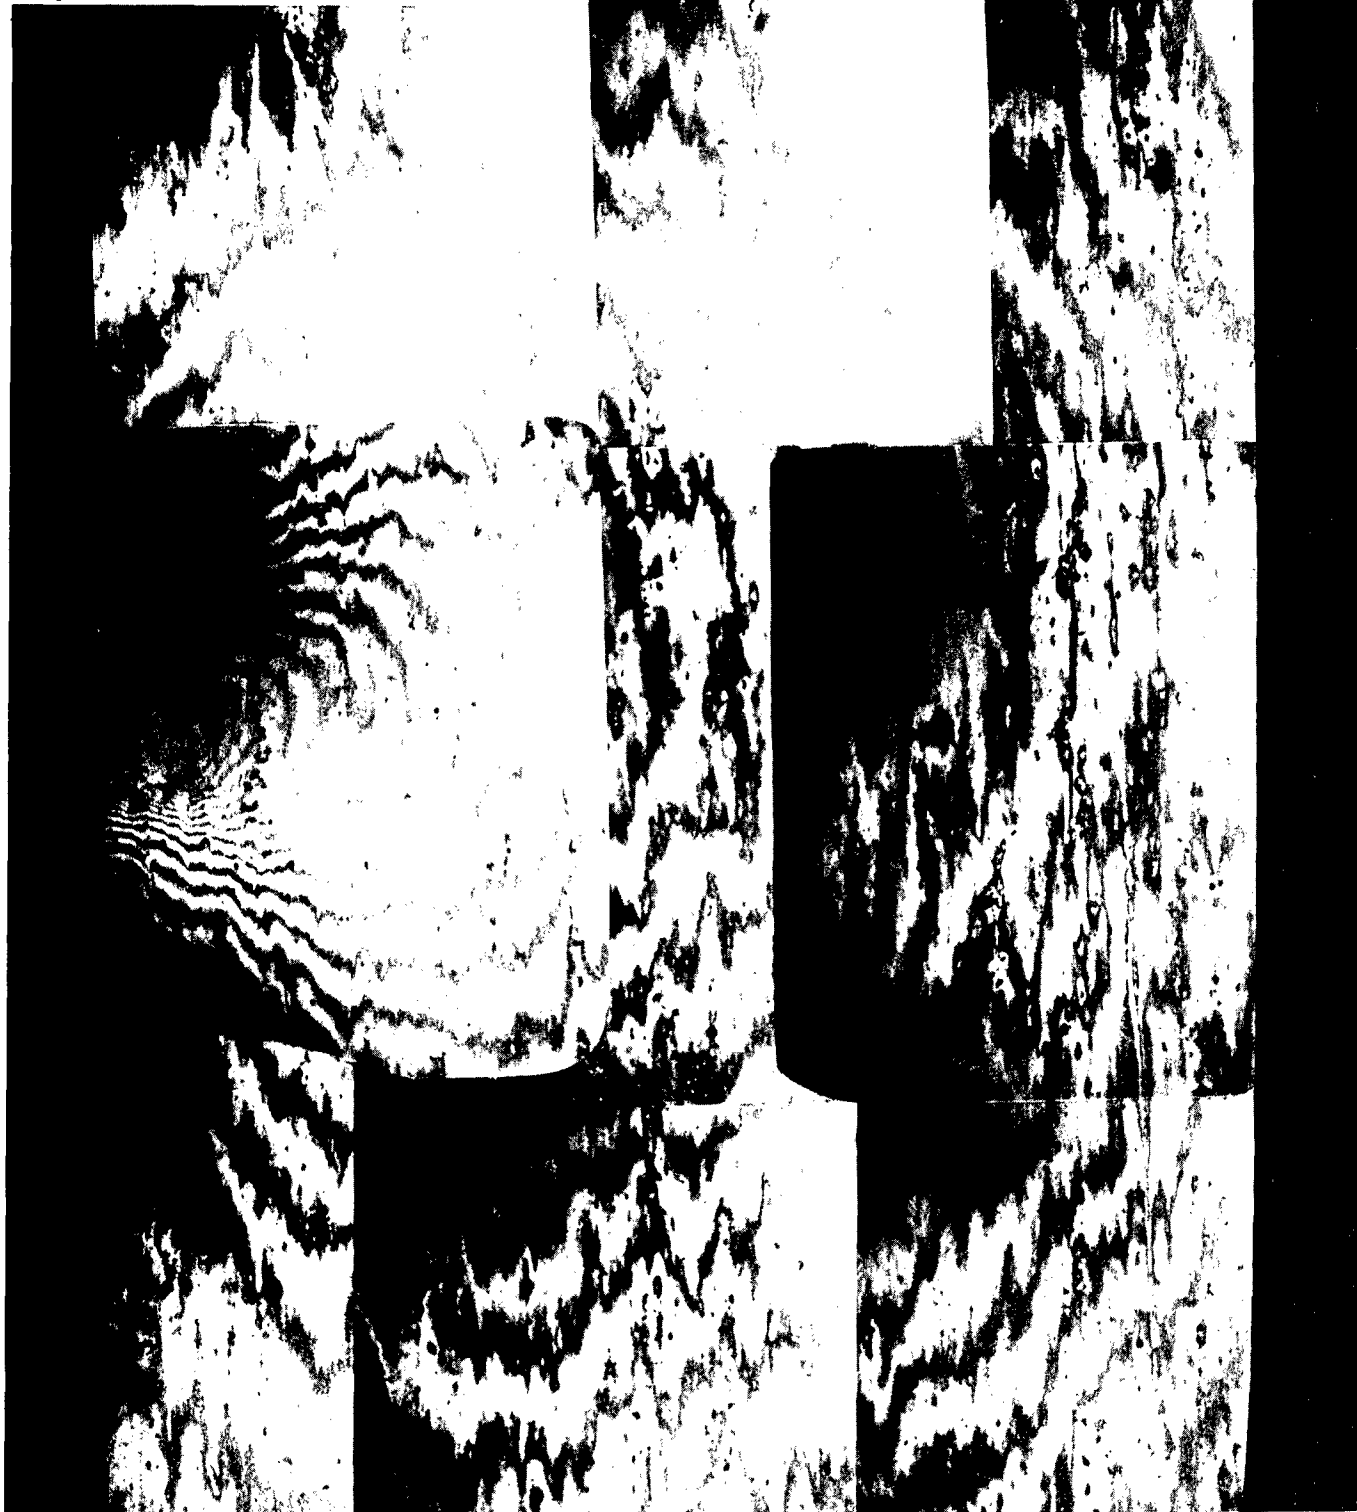
Figure 83. Interferometry Photograph of a Loaded Crack in a 2024-T351 Specimen

2024-T351,  $a = 0.23$  inch  
 $\sigma_x = -1.5$ ,  $\sigma_y = 15$  ksi at load  
Magnification: 46.3X  
Test Case 60  
Specimen 2-40-4

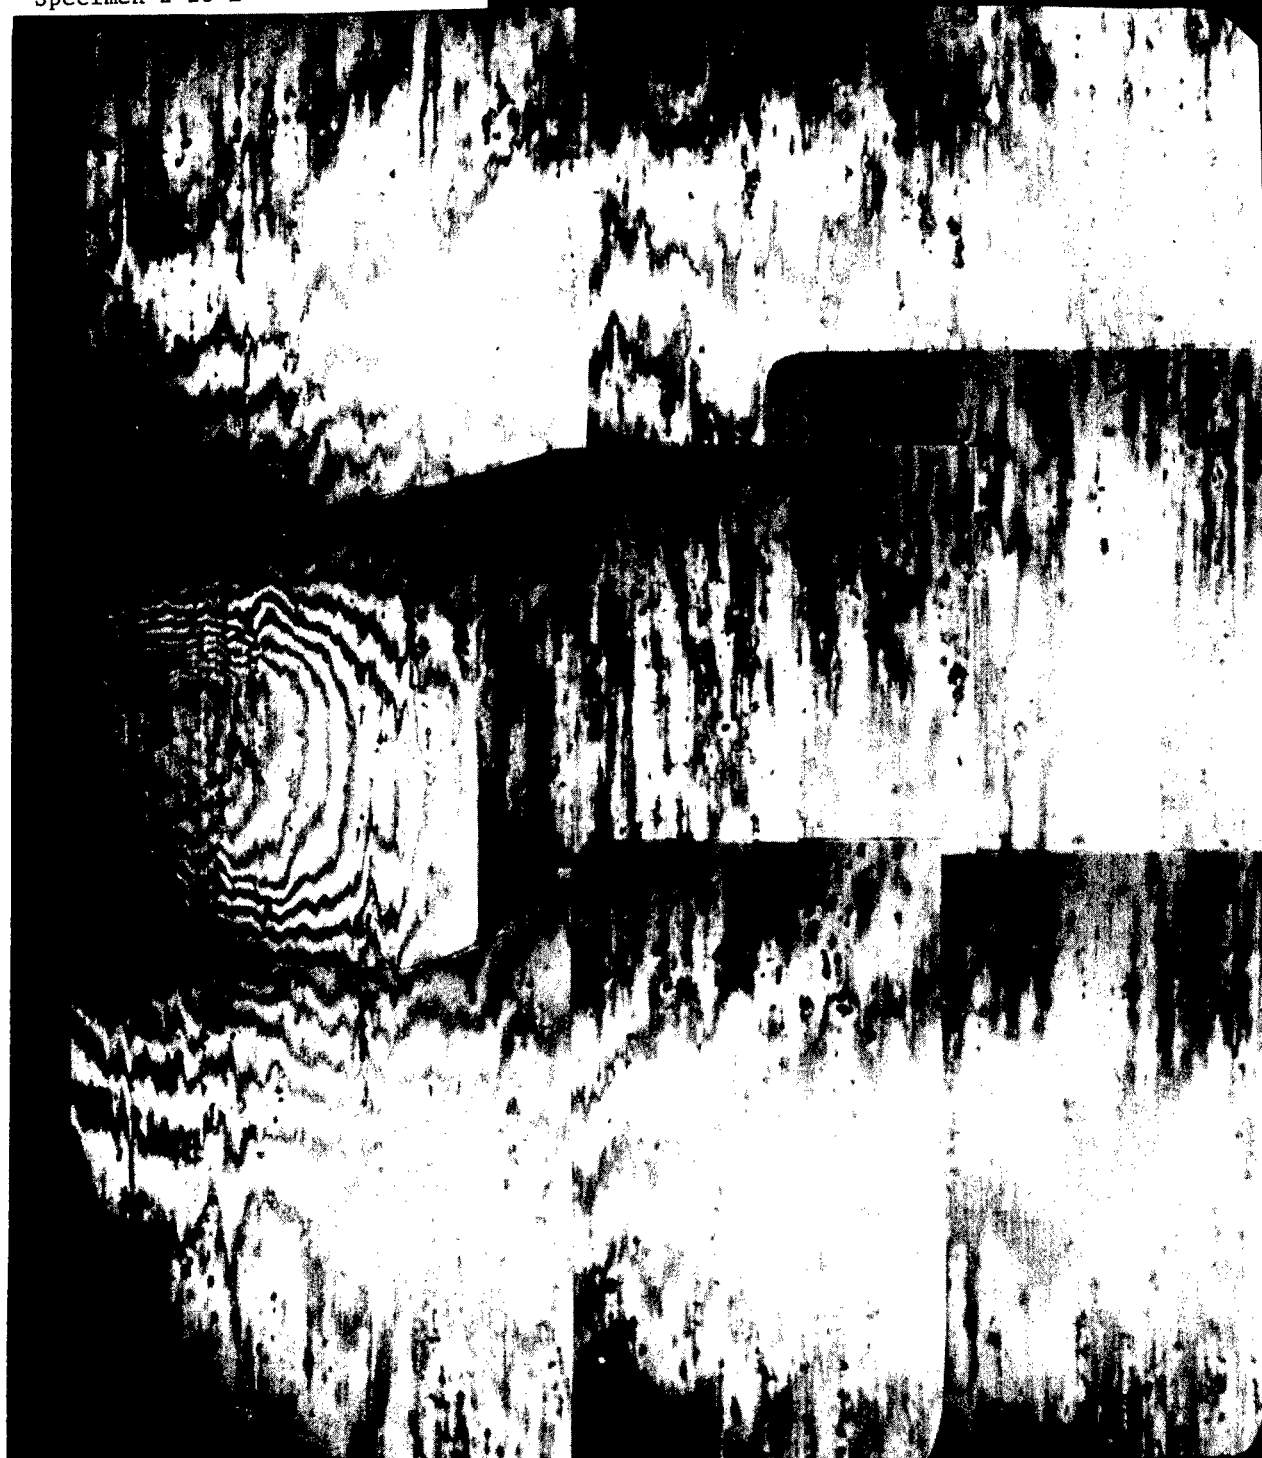
Figure 86. Interferometry Photograph of an Unloaded Crack in a 2024-T351 Specimen

2024-T351,  $a = 0.15$  inch  
 $\sigma_x = -1.25$ ,  $\sigma_y = 25$  ksi unloaded  
Magnification: 46.0X  
Test Case 66  
Specimen 2-28-1

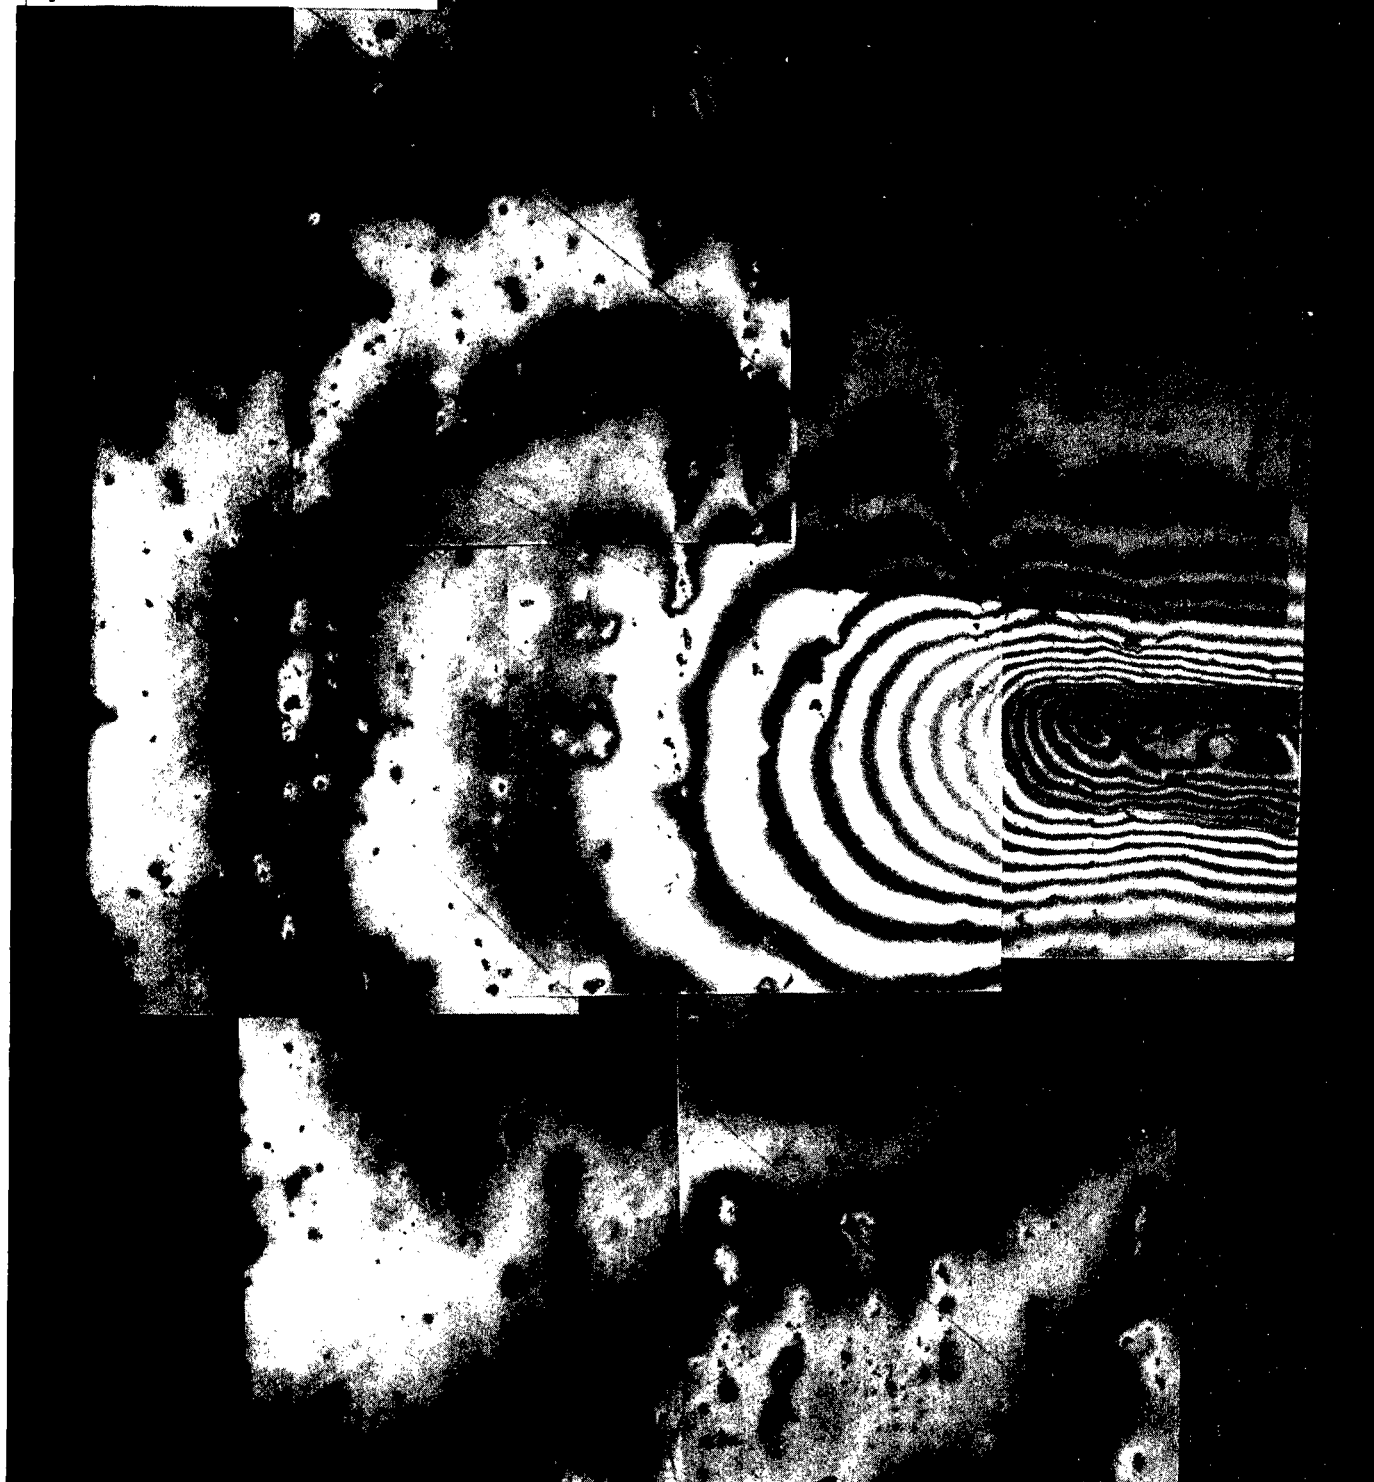
Figure 93. Interferometry Photograph of an Unloaded Crack in a 7075-T7351 Specimen

7075-T7351,  $a = 0.50$  inch  
 $\sigma_x = 0$ ,  $\sigma_y = 12$  ksi unloaded  
Magnification: 73.0X  
Test case 99  
Specimen - 7-114-3

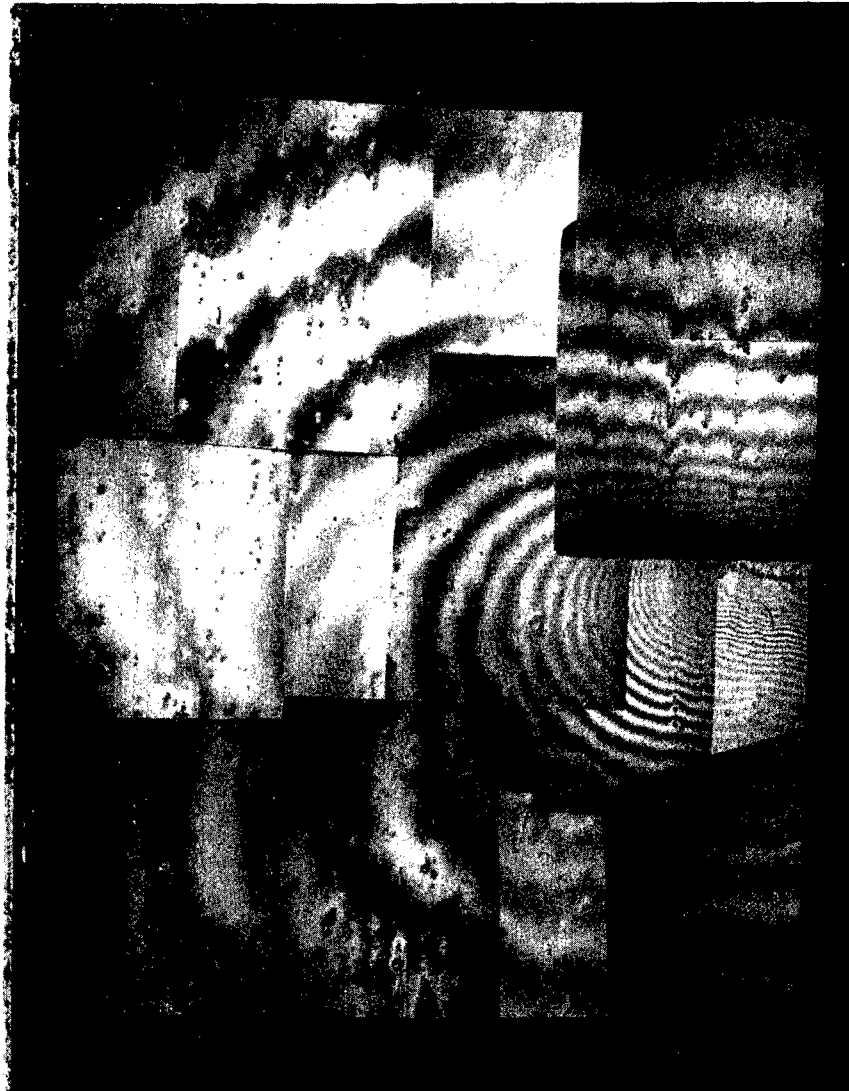
Figure 95. Interferometry Photograph of an  
Unloaded Crack in a 7075-T7351  
Specimen

7075-T7351,  $a = 1.005$  inch  
 $\sigma_x = 0$ ,  $\sigma_y = 12$  ksi unloaded  
Magnification: 21.6X  
Test case 99  
Specimen 7-114-5

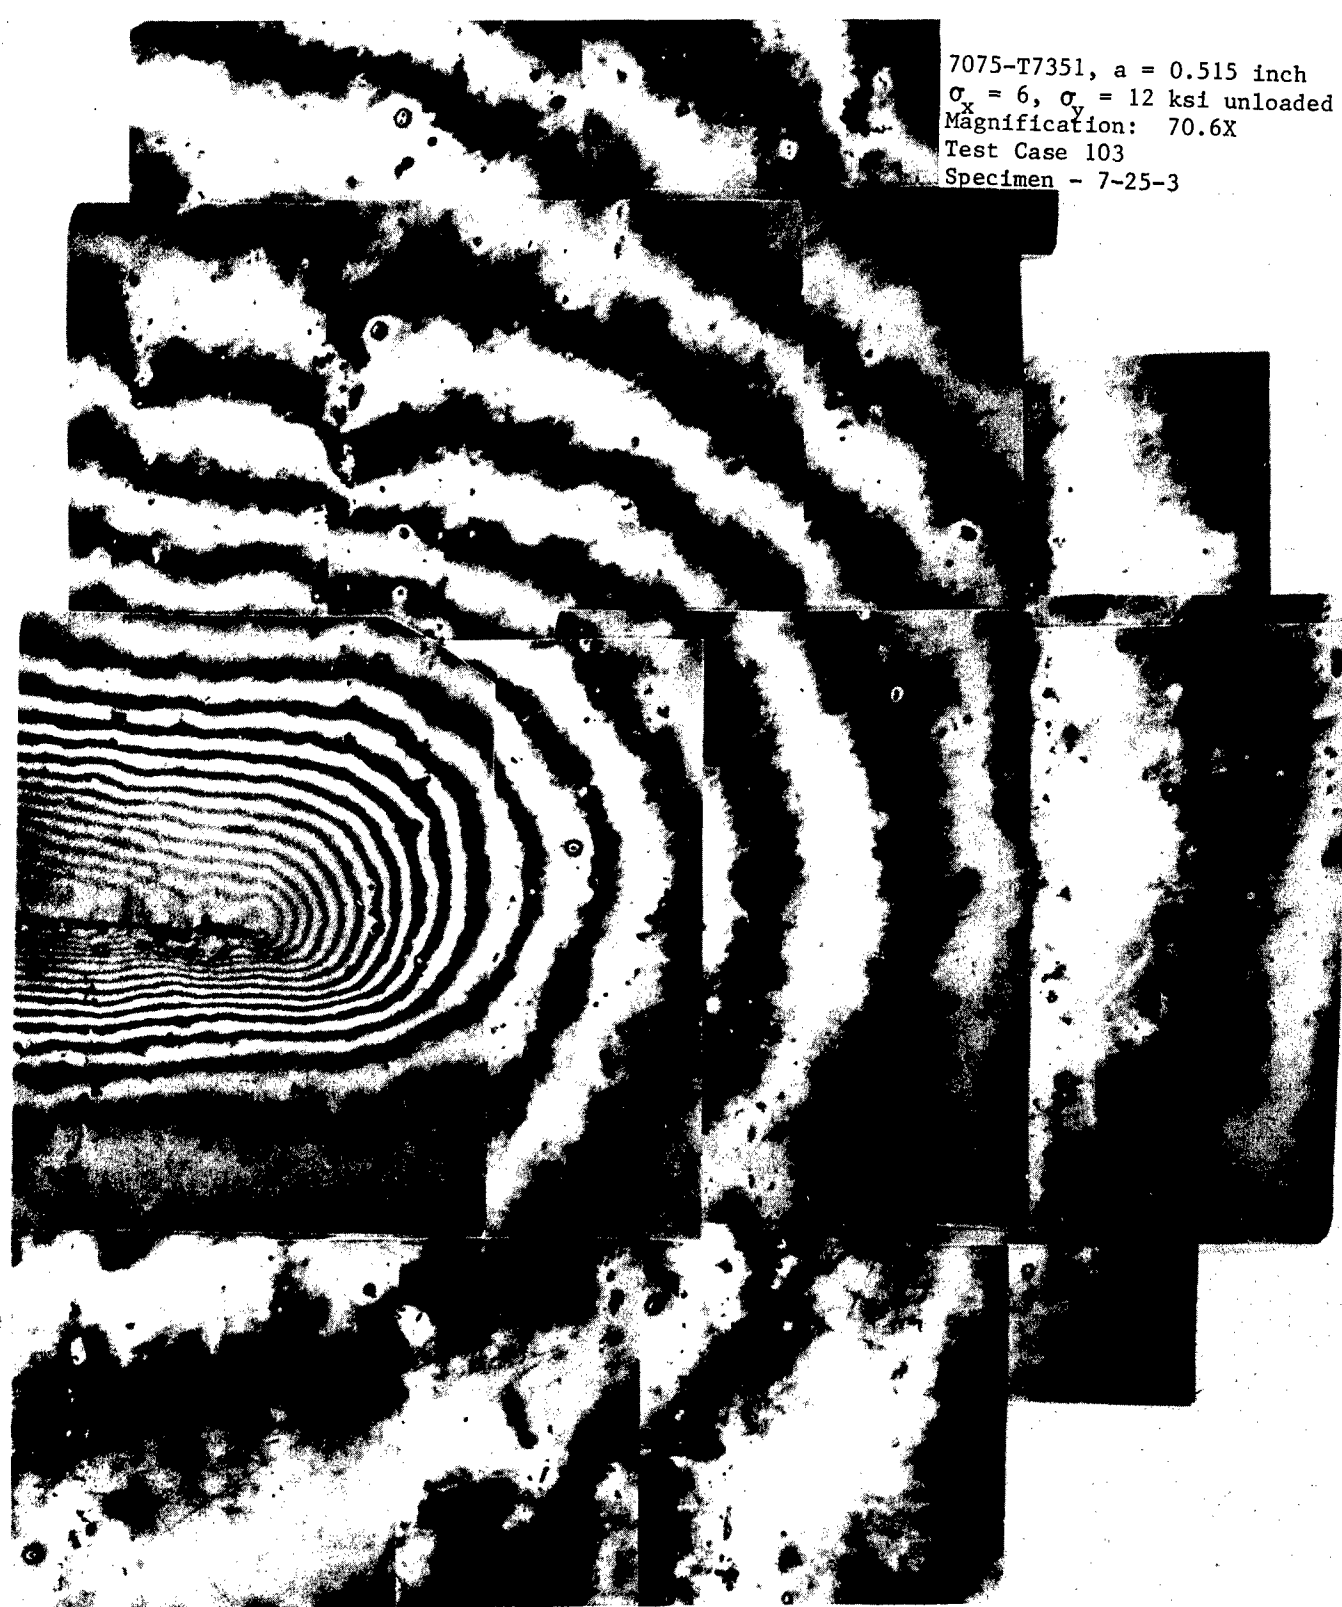
Figure 99. Interferometry Photograph of a Crack Unloaded from a Single Overload in a 7075-T7351 Specimen

7075-T7351,  $a = 0.515$  inch  
 $\sigma_x = 6$ ,  $\sigma_y = 12$  ksi unloaded  
Magnification: 70.6X  
Test Case 103  
Specimen - 7-25-3

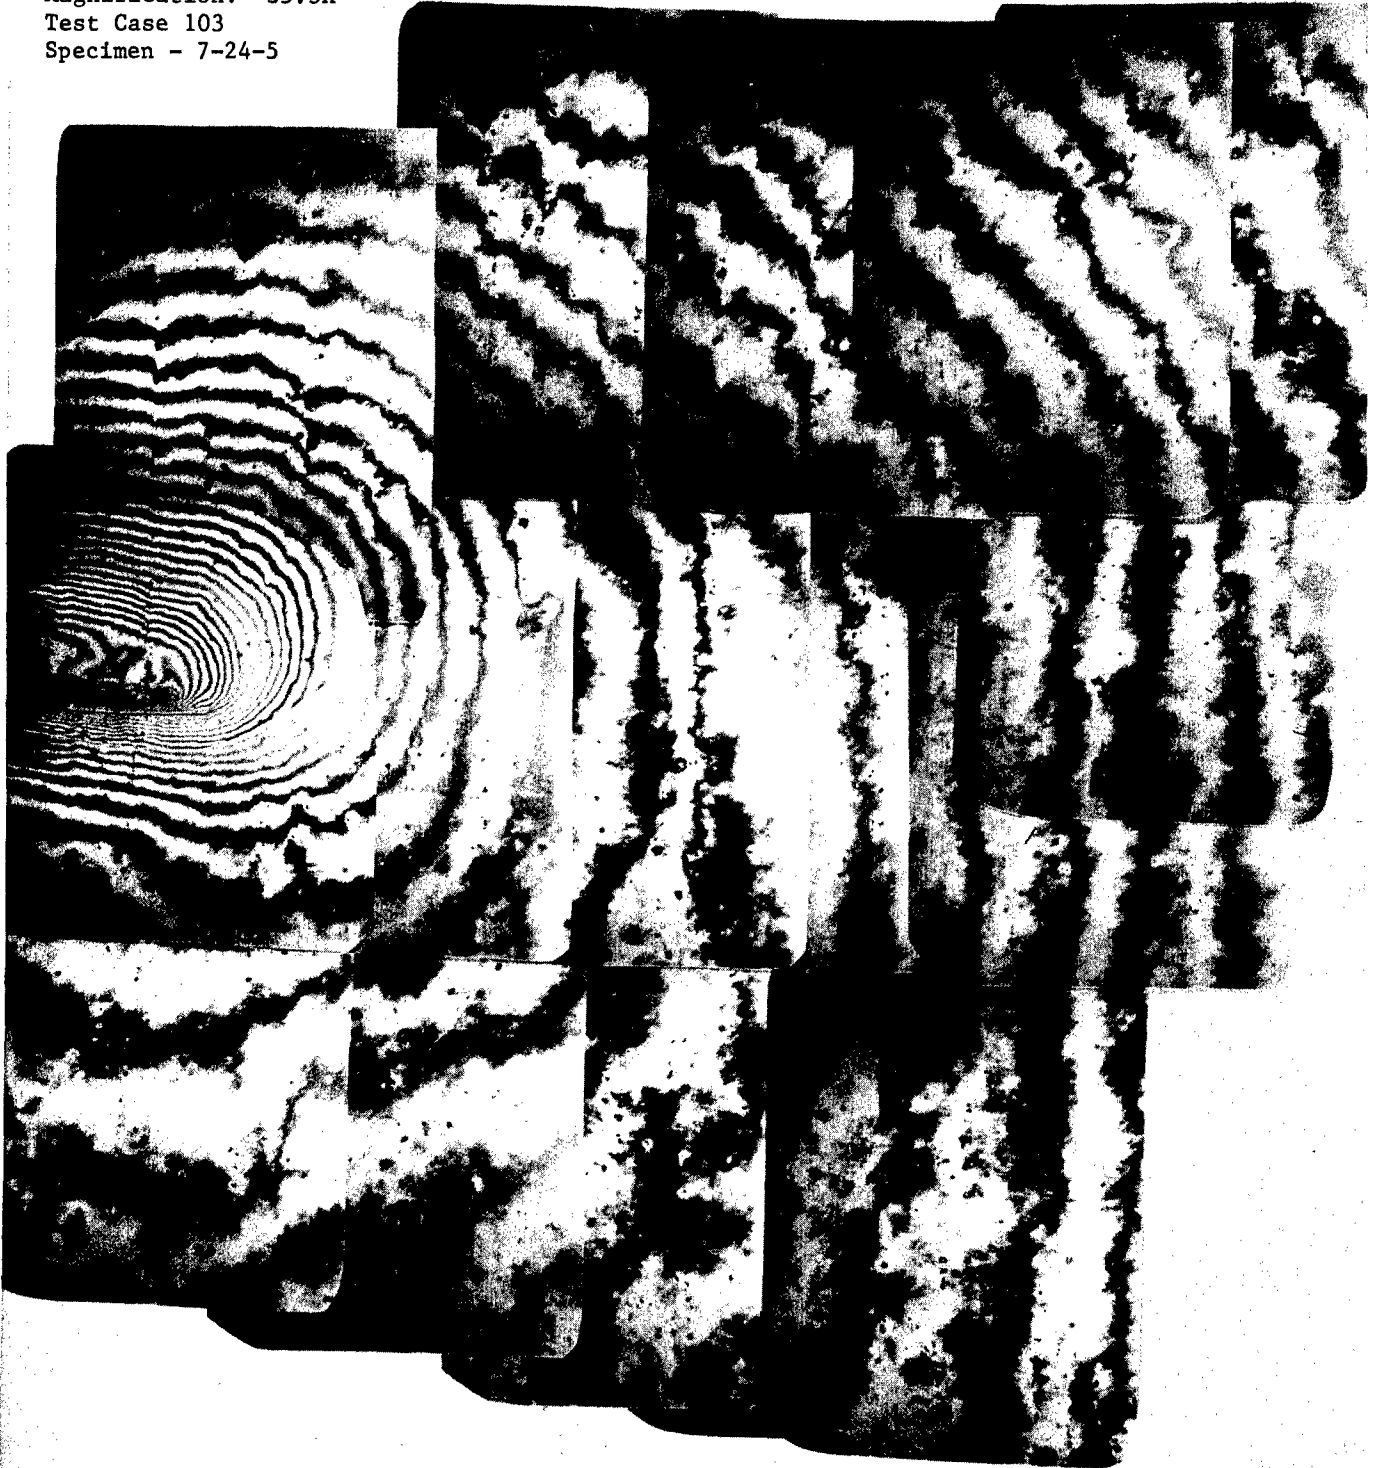
Figure 102. Interferometry Photograph of an Unloaded Crack in a 7075-T7351 Specimen

7075-T7351,  $a = 1.015$  inch  
 $\sigma_x = 6$ ,  $\sigma_y = 12$  ksi unloaded  
Magnification: 35.3X  
Test Case 103  
Specimen - 7-24-5

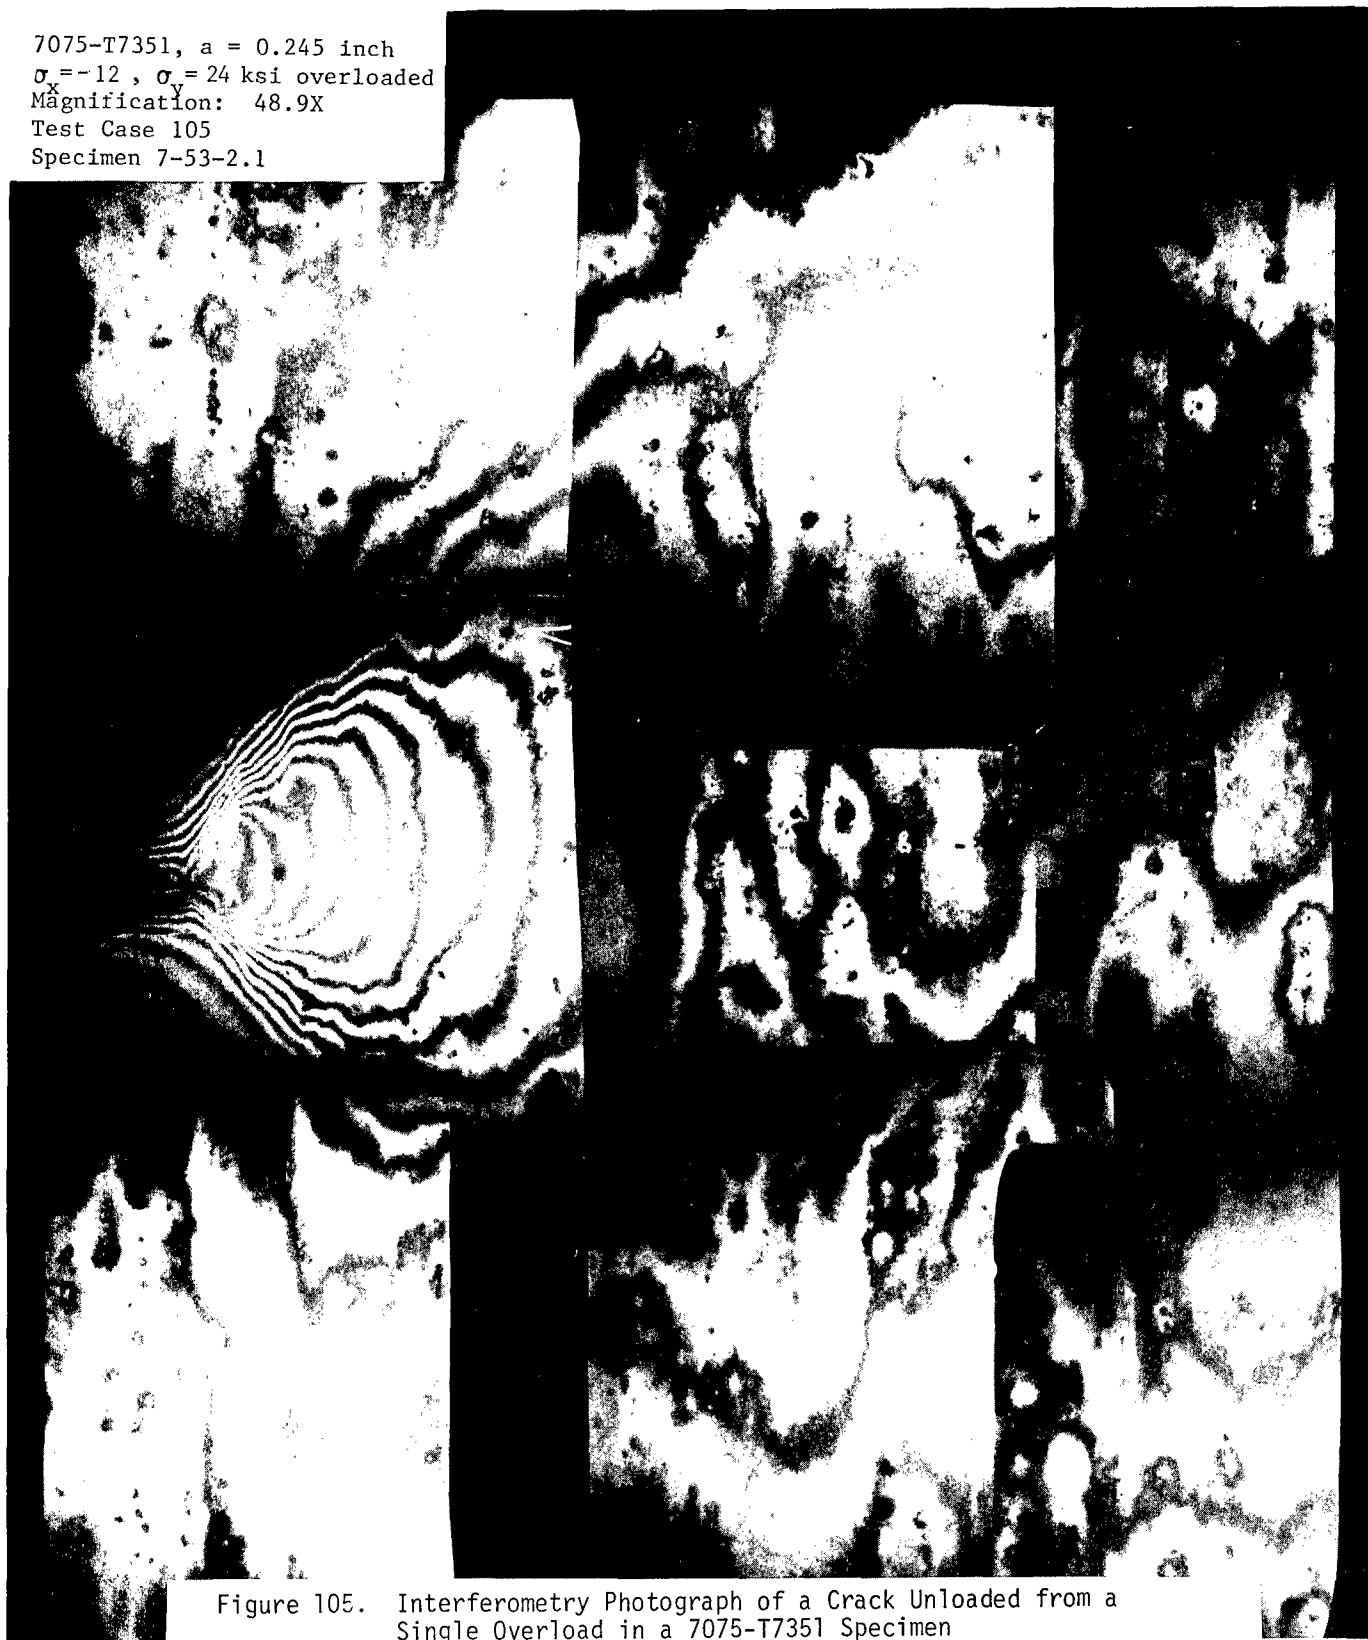
Figure 105. Interferometry Photograph of a Crack Unloaded from a Single Overload in a 7075-T7351 Specimen

7075-T7351,  $a = 0.245$  inch  
 $\sigma_x = -12$ ,  $\sigma_y = 24$  ksi overloaded  
Magnification: 48.9X  
Test Case 105  
Specimen 7-53-2.1
